AIRCRAFT CARGO COMPARTMENT FIRE TEST
SIMULATION PROGRAM

R. E. Blumke
McDonnell Douglas Corporation
Douglas Aircraft Company
3855 Lakewood Blvd.
Long Beach, California 90846

NAS2-8699
CR151951-NASA Report Number
January 1977

Final Report for Period October 1974 - January 1977

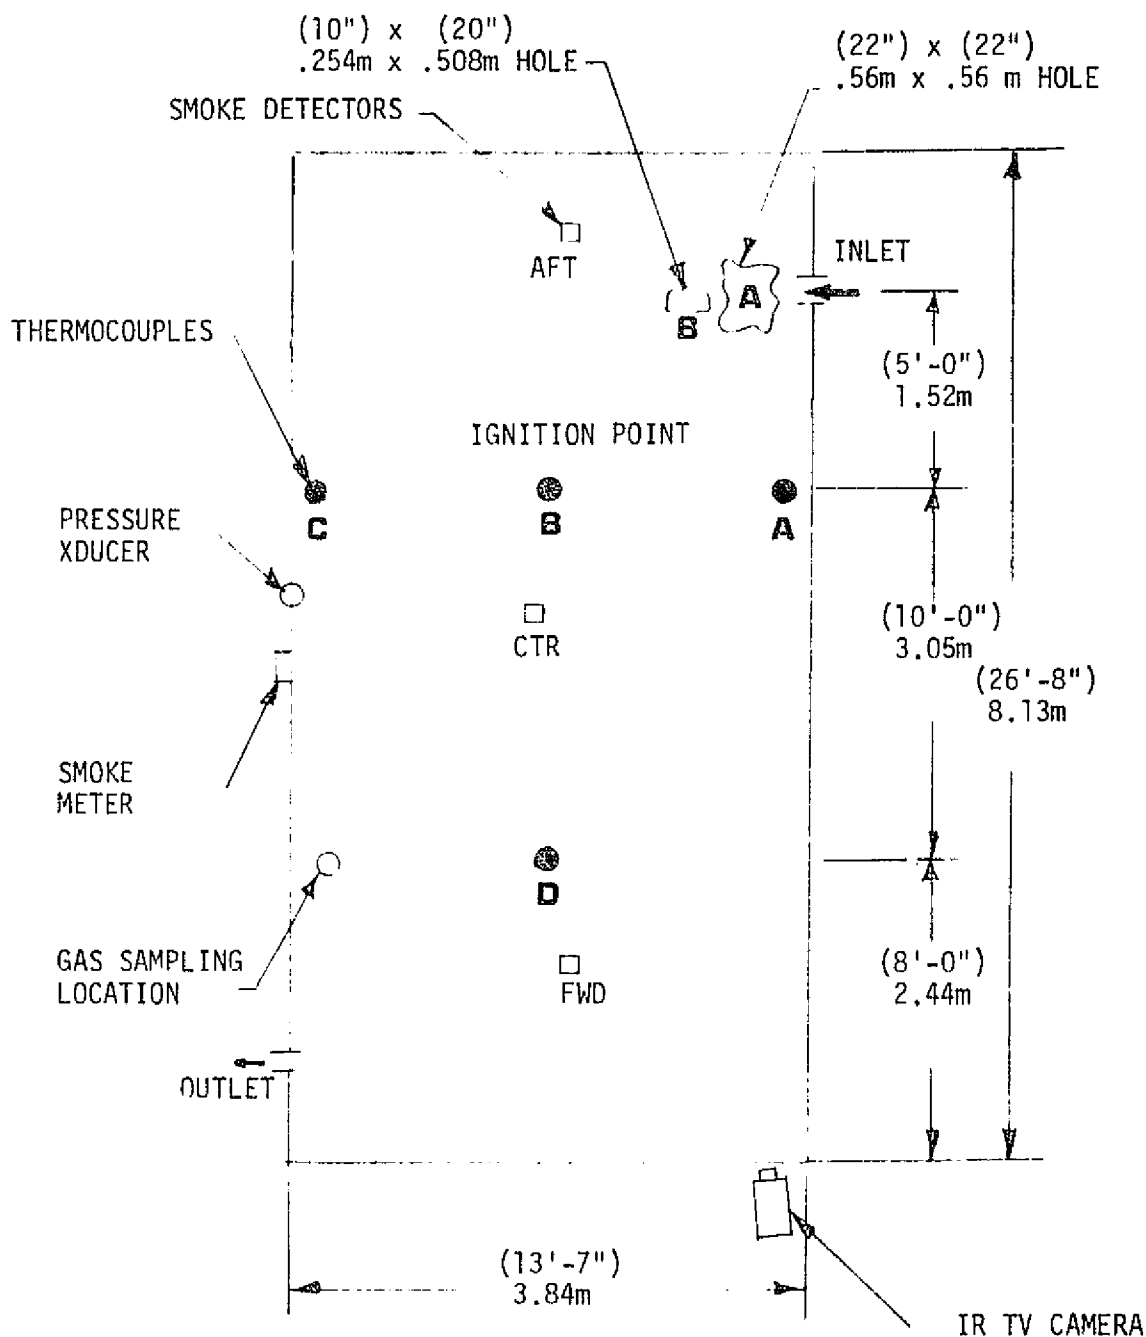
FIGURE 4. SCHEMATIC OF COMPARTMENT INSTRUMENTATION SHOWING RELATIVE LOCATIONS, AND DAMAGED CEILING AREAS - TEST NO. 1

Post-test examination revealed two holes burned through the ceiling liner adjacent to the vent inlet. The holes were approximately 55.88cm x 55.88cm (22 x 22 inches) and 25.4cm x 50.8cm (10 x 20 inches) as shown in Figures 4, 28 and 29. Though extensive areas of the ceiling and sidewall liner were delaminated and baked free of resin, no other burnthroughs existed.

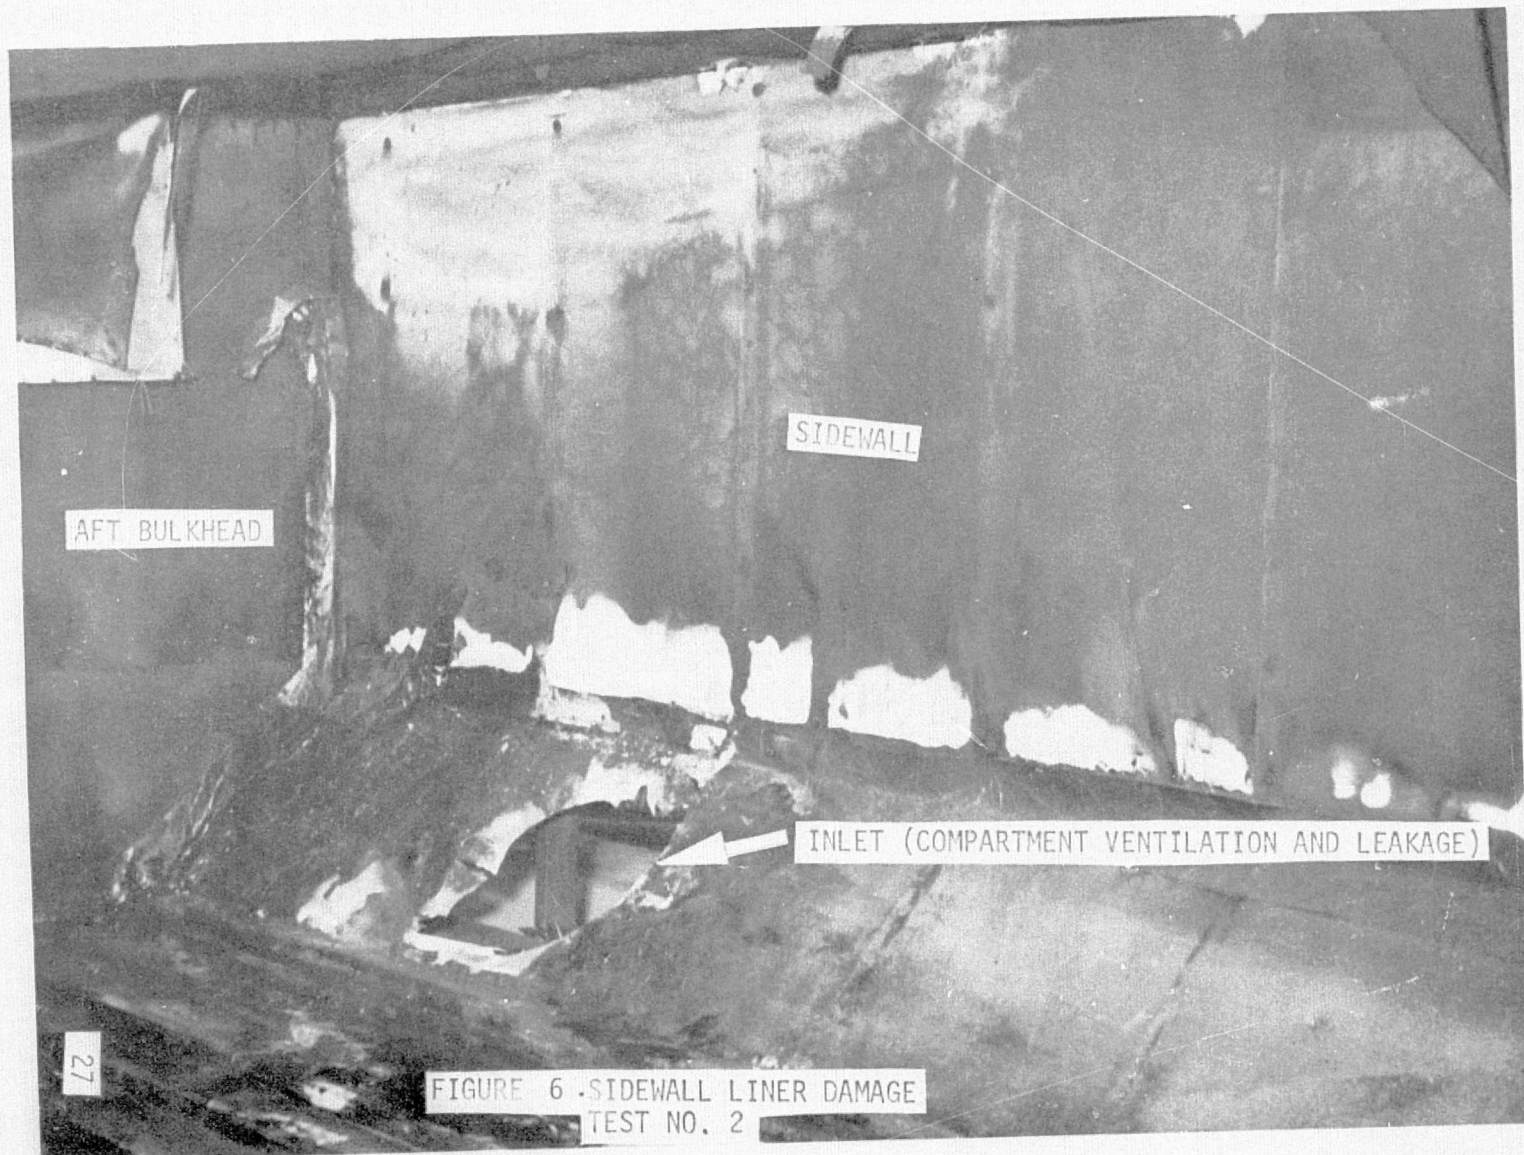
FIGURE 6 .SIDEWALL LINER DAMAGE
TEST NO. 2

Extensive areas of the ceiling were delaminated and baked free of resin but no other burnthroughs existed. The sidewall liner above the inlet also showed delamination and was baked free of resin but no burnthroughs; see Figure 6. Although the resin bakes free from the fiberglass the mat remains and provides an effective barrier against flame penetration.

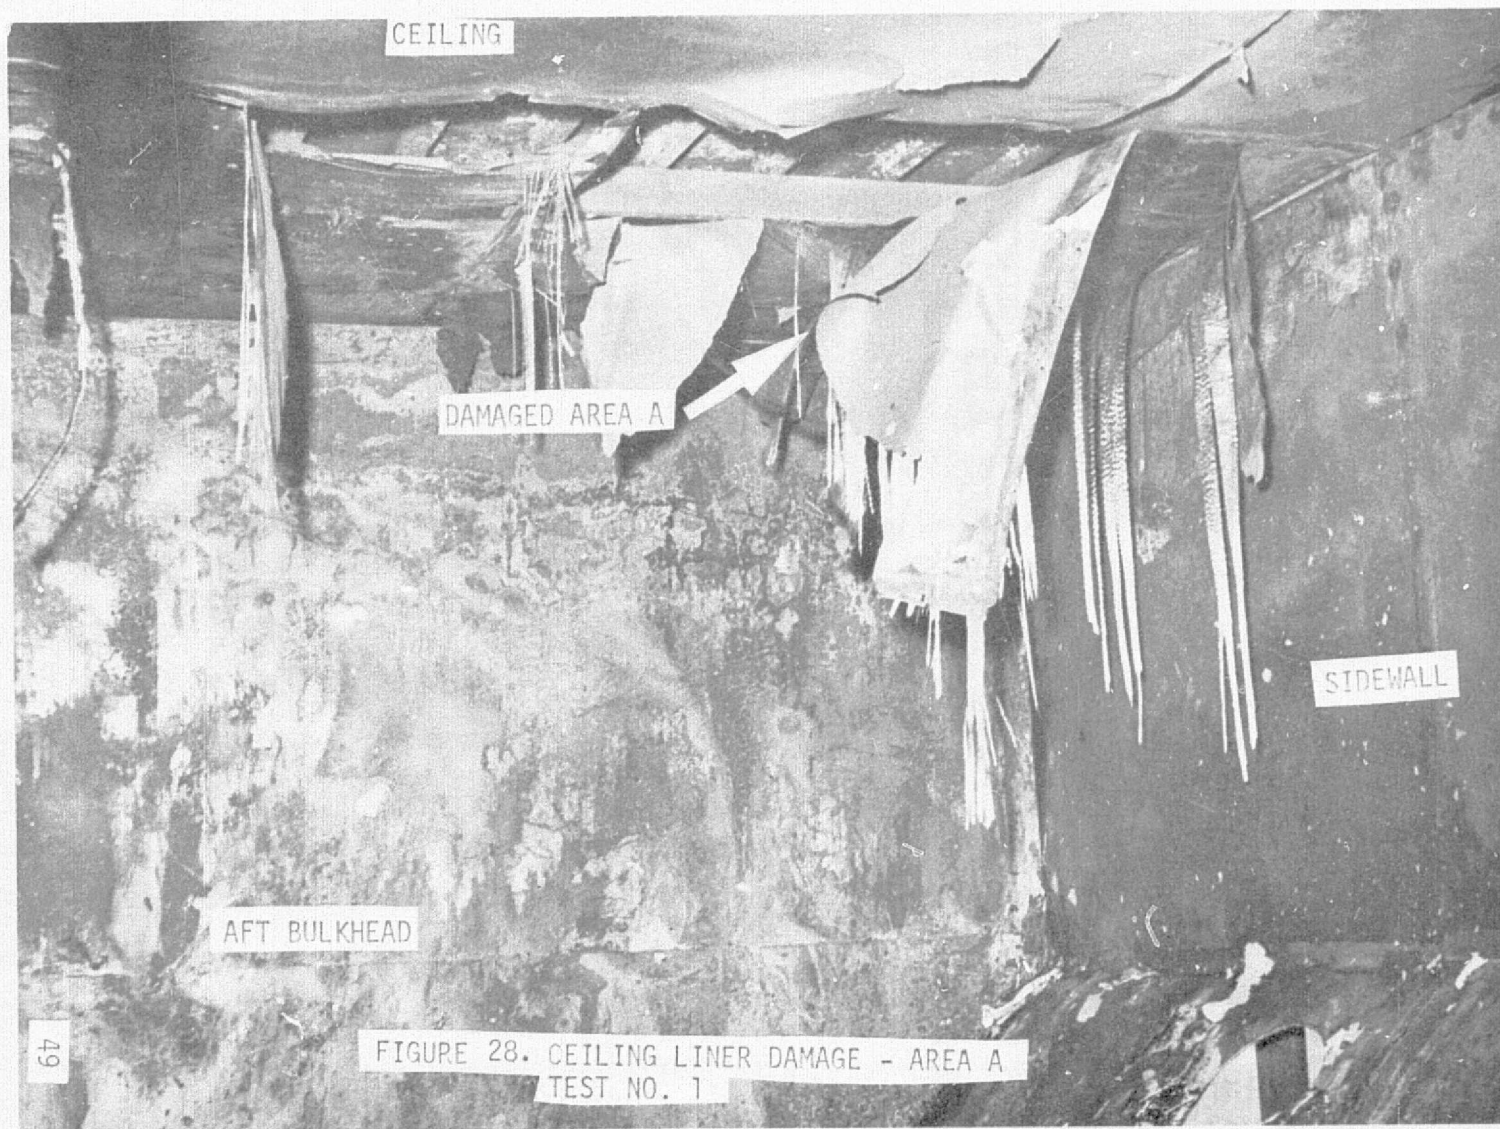
burned locally in the open spaces near the inlet, eventually causing the liner burnthrough. Evidence was found of deep seated burning at the ignition source, but the liner above the ignition source was not damaged as much as would have been expected had the final combustion process occurred there.

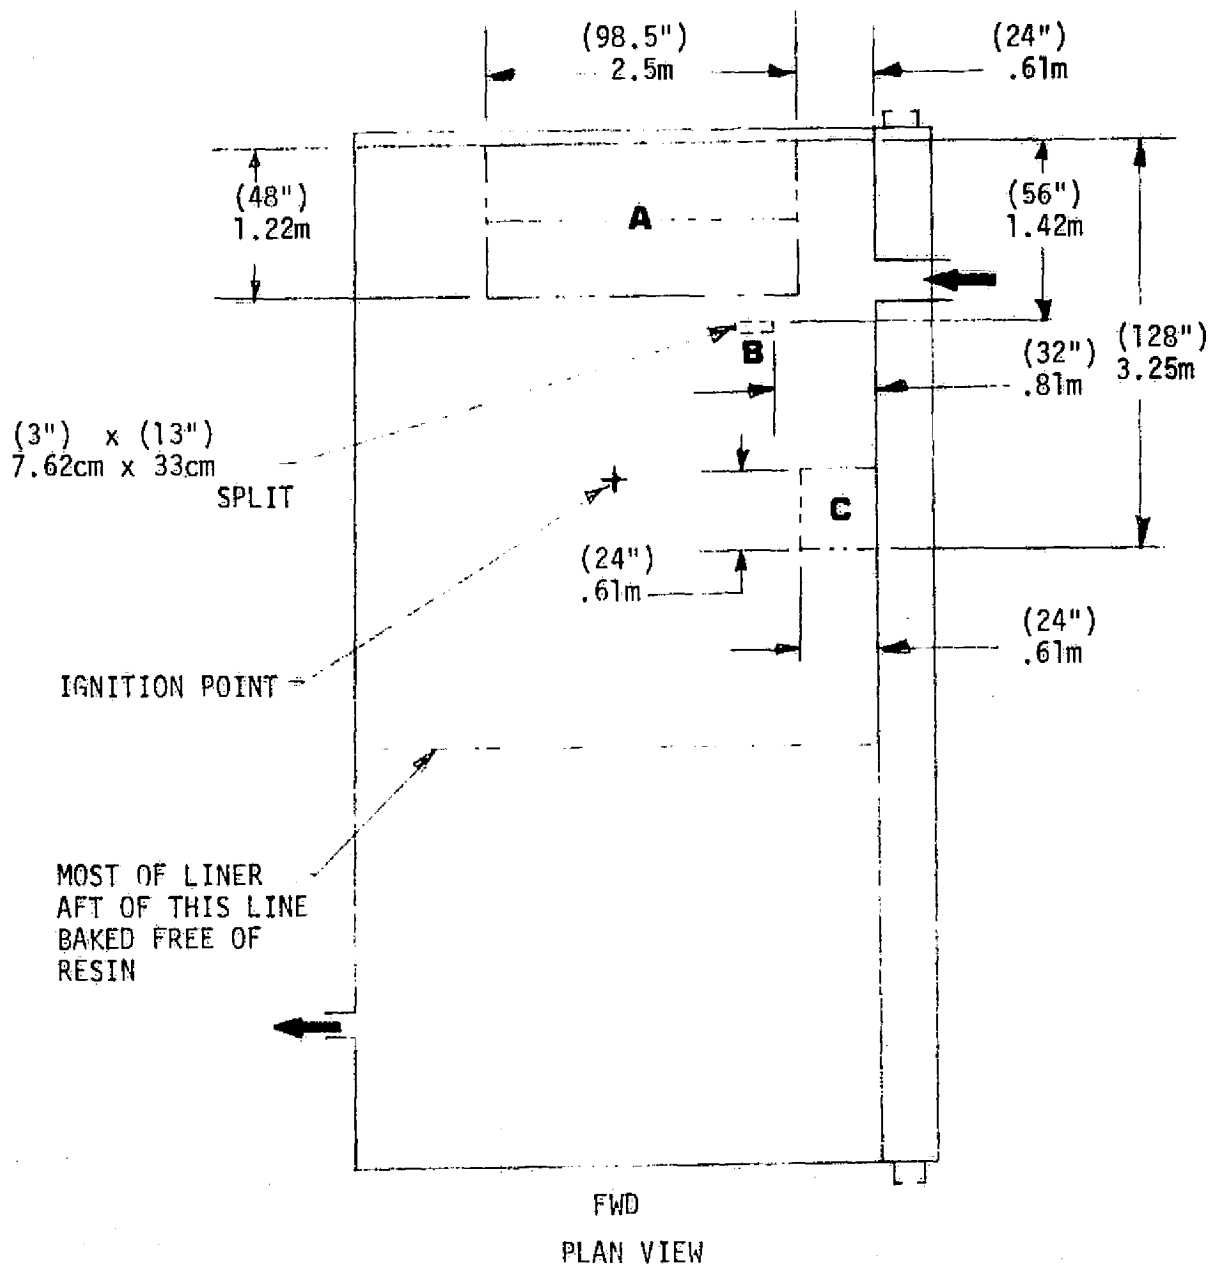
FIGURE 52. SCHEMATIC DAMAGED AREAS OF CEILING LINER RELATIVE
TO IGNITION POINT - TEST NO. 2

Figures 52 through 56 show the ceiling liner damage. The greatest damage occurred adjacent to and in front of the airflow inlet where the fire was centered. The ceiling area over the ignition source did not burn through. When the resin in the fiberglass bakes free only the fiberglass mat remains. This mat without the resin has little strength. The weight of the fiberglass panel causes the structural attachments to shear through the mat and the panel falls and hangs into the compartment, see Figure 53. New design techniques for attachment should be considered and tested in future programs. A split 7.62cm x 33cm (3 in. x 13 in.) occurred in the ceiling
